GADSDEN INDEPENDENT SCHOOL DISTRICT

PAVEMENT ANALYSIS REPORT

RIVERSIDE, SUNLAND PARK, DESERT VIEW

FEBRUARY 8, 2012

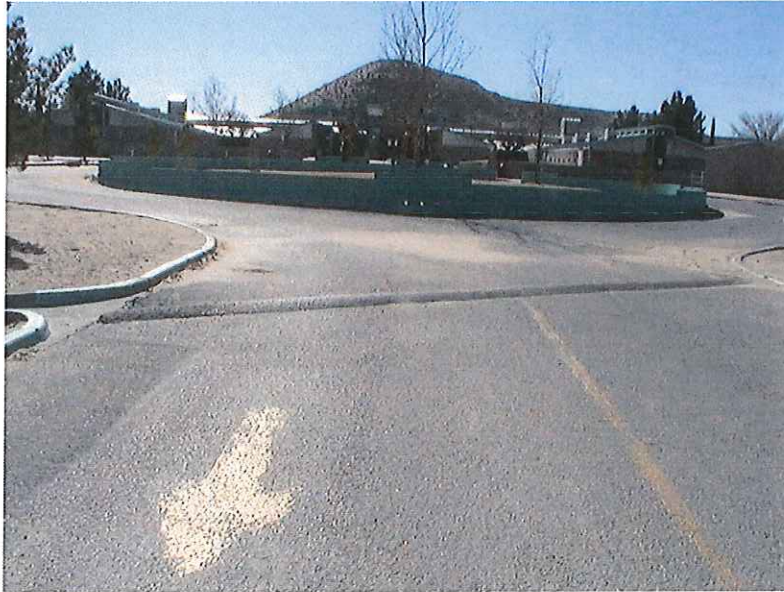
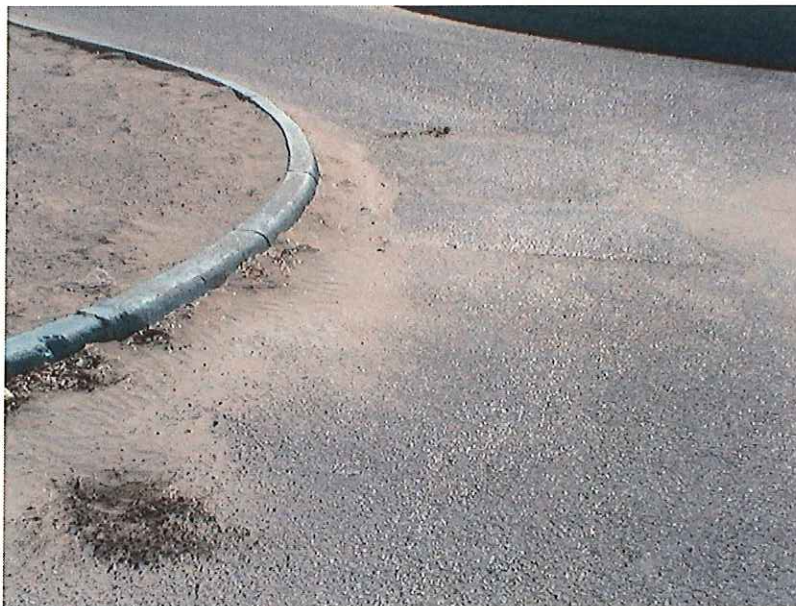
The main circle drive entrance to Desert View appears to be part of the original construction of the school building and is showing signs of disintegration and wear. Raveling and weathering of the pavement is evident by a rough jagged pavement surface. Pavement aggregate polishing is also apparent and is due to prolonged traffic use over the surface. The turn out to Valle Vista Dr. shows the most extensive surface damage with various potholes and repairs. This portion of asphalt paving has reached the extent of its expected useful life and will require complete removal and replacement of the asphalt surface.

- Main Circle Drive Entrance – Poor Condition - Complete removal and replacement of asphalt surface 2 to 4 years.
Complete Asphalt Removal & Replacement \$78,000
- Faculty and Parent / Visitor Parking – Fair Condition – 1" asphalt surface overlay or crack repair and pavement preservation slurry sealer 2 to 4 years.
1" Asphalt Overlay \$7,500 each (X2)
Crack Repair & Pavement Preservation Slurry treatment \$3,500 each (X2)
- Bus Drop Off – Good Condition - pavement preservation slurry within 6 to 8 years.
Pavement Preservation Slurry Treatment \$2,000
- Student Drop Off – Good Condition – pavement preservation slurry within 6 to 8 years.

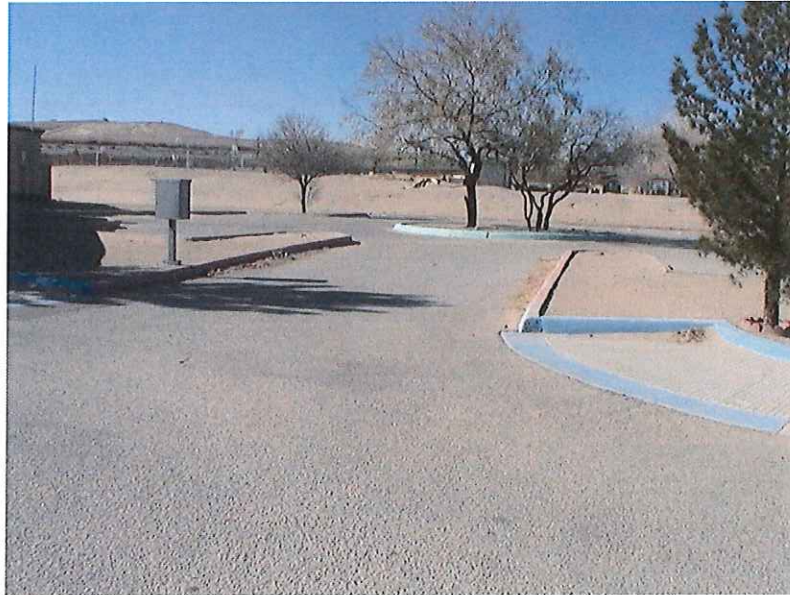
Figure 4 - Desert View Faculty Parking

The Faculty and Parent/Visitor parking lots east and west of the circle drive show less wear than the main circle drive, but do exhibit signs of raveling and weathering. Much of the asphalt binder has been lost over the years and reveals a rough aggregate finish. Typically these two parking areas only experience light vehicle traffic with only limited heavy truck traffic. A 1" asphalt surface overlay would extend the useful life cycle by 8 to 10 years or a crack repair and a pavement preservation slurry seal treatment could be used to extend it 6 to 8 years. The 1" asphalt surface overlay would provide extended useful life and overall

improved performance. However the crack repair and pavement preservation treatment would be recommended as a minimum maintenance objective.

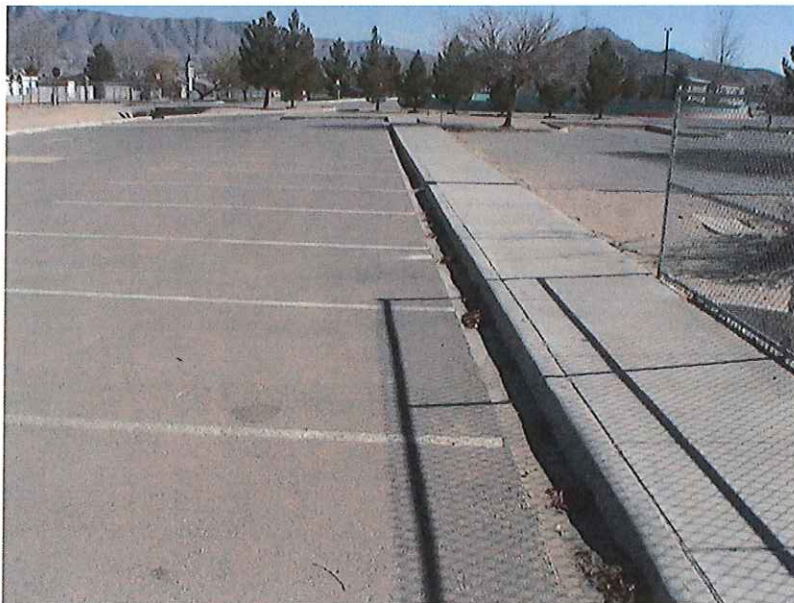
Figure 6 - Desert View Parent Student Drop Off

The student drop off on the west side is also new and in good condition. Typical sand and debris removal along the gutter pans and drainage paths is also recommended. A pavement preservation slurry treatment within the next 6 to 8 years will extend the pavement life cycle. Associated curb and gutters, sidewalks, ramps and drainage structures appeared in good condition and only regular cleaning is required. New striping and marking will be required after any pavement preservation treatment is completed.

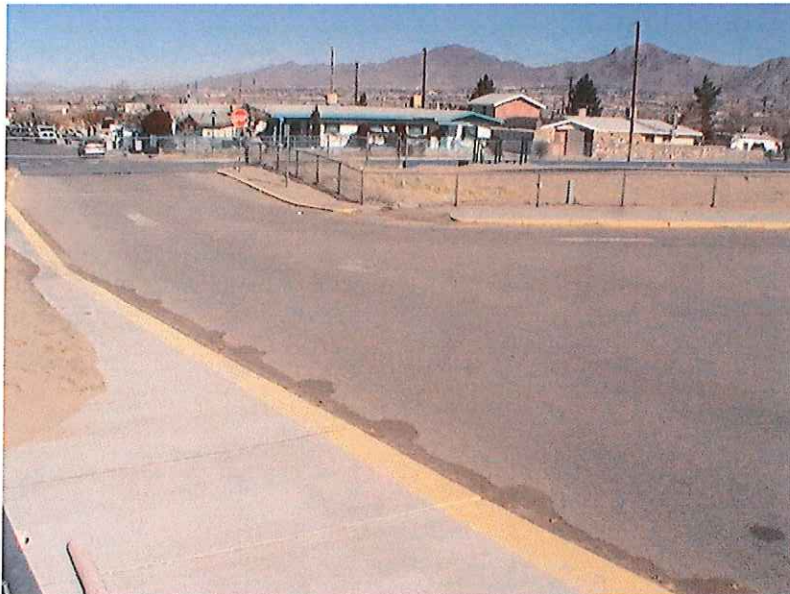
Figure 12 - Sunland Park ES Bus Drop Off

The separate Bus Drop Off east of the main entrance is in good condition, with the exception of accumulation of fine sand particles. General pavement sweeping of the top surface and along the curb line will allow for appropriate drainage flow patterns and improve general appearance. A pavement preservation treatment should be scheduled within the next 6 to 8 years to extend the pavement performance.

- Bus Drop Off – Good Condition – Pavement preservation slurry seal within 6 to 8 years.

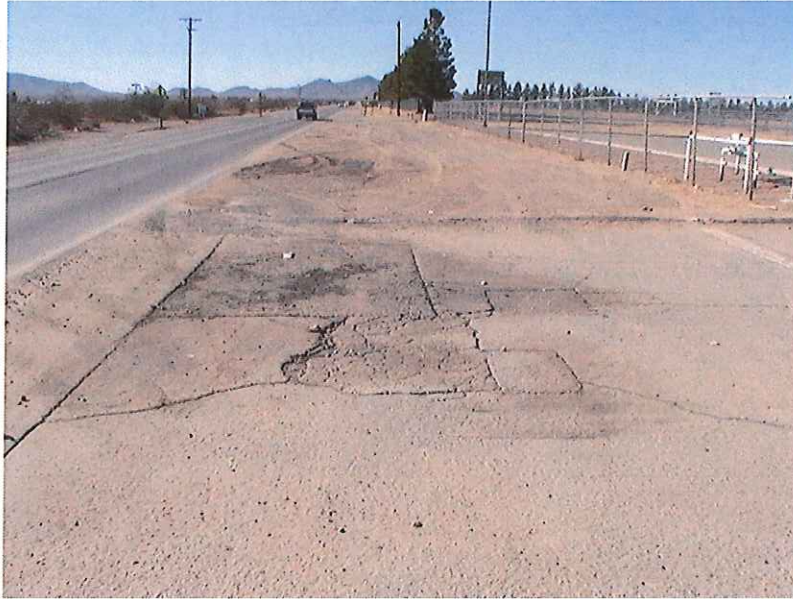
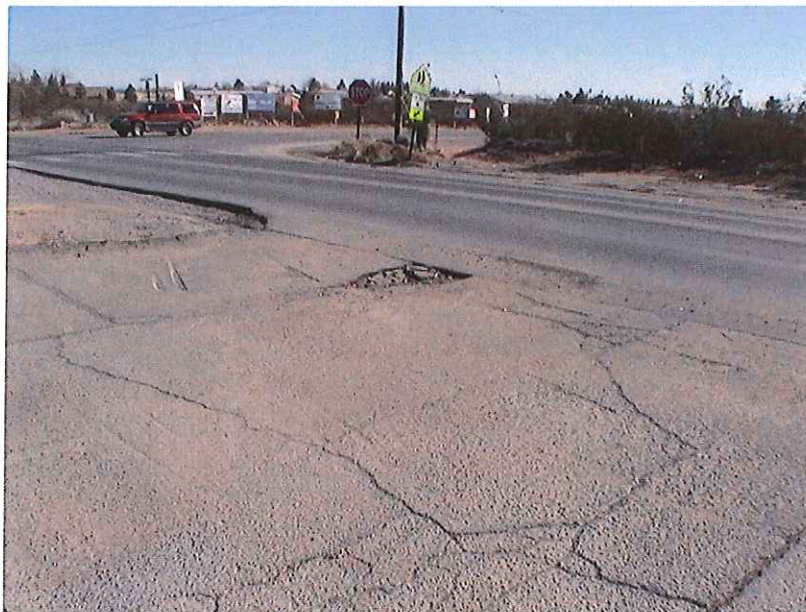
The Main parking and parent student drop off is in a dilapidated state with many longitudinal and transverse cracks throughout. As expected for the age of the asphalt pavement, much of the binder material has been lost over time and the driving surface is rough and worn with ruts and surface disintegration. The main access from Lisa Drive is in very poor condition and is in need of immediate repair. Large potholes and broken pavement sections impede traffic to and from the facility and should be a priority for complete replacement. The asphalt curb on the east end of the parking lot is broken with various sections missing in many areas along its length. Potholes and temporary repairs are also evident throughout the pavement surface. It is recommended that the entire parking surface be removed and replaced. Additional installation of curb and gutters, as well as sidewalks should be included as part of the overall project. This parking facility is generally

inadequate to handle the current volume of traffic and additional parking should be considered. The overall condition of this parking facility warrants complete removal and replacement as soon as practical for the District.

- Main Parking and Parent Student Drop Off – Poor Condition- Complete removal and Replacement including turnouts within the next 1 to 3 years.
