GADSDEN INDEPENDENT SCHOOL DISTRICT

PAVEMENT ANALYSIS REPORT

RIVERSIDE, SUNLAND PARK, DESERT VIEW

FEBRUARY 8, 2012

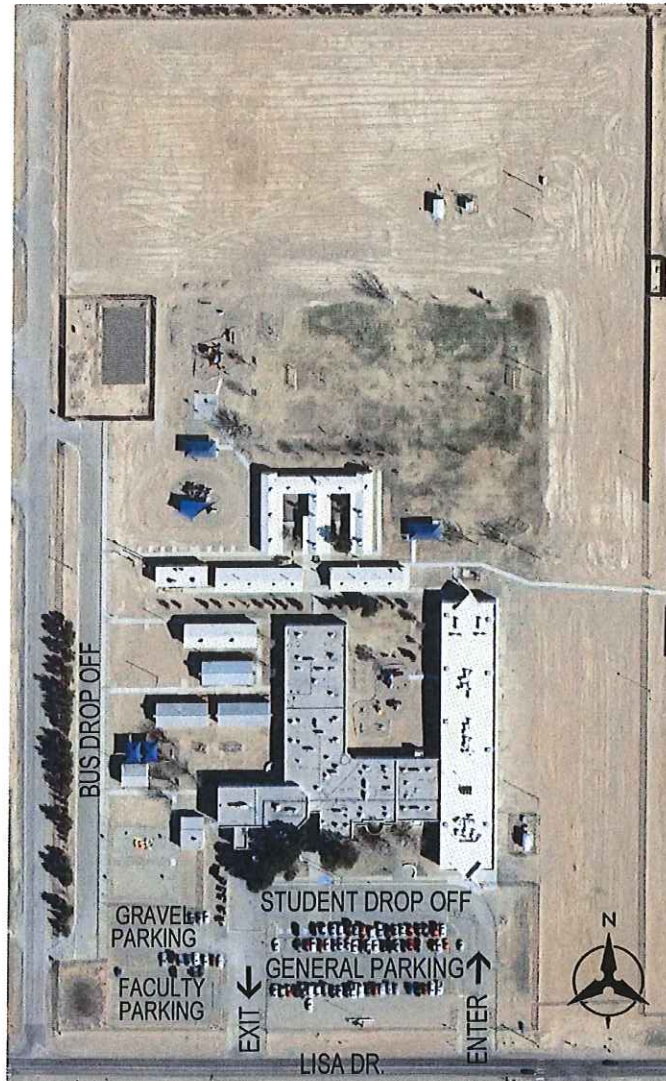
Figure 18 – Chaparral Elementary School

The Main parking and parent student drop off is in a dilapidated state with many longitudinal and transverse cracks throughout. As expected for the age of the asphalt pavement, much of the binder material has been lost over time and the driving surface is rough and worn with ruts and surface disintegration. The main access from Lisa Drive is in very poor condition and is in need of immediate repair. Large potholes and broken pavement sections impede traffic to and from the facility and should be a priority for complete replacement. The asphalt curb on the east end of the parking lot is broken with various sections missing in many areas along its length. Potholes and temporary repairs are also evident throughout the pavement surface. It is recommended that the entire parking surface be removed and replaced. Additional installation of curb and gutters, as well as sidewalks should be included as part of the overall project. This parking facility is generally

inadequate to handle the current volume of traffic and additional parking should be considered. The overall condition of this parking facility warrants complete removal and replacement as soon as practical for the District.
