(DRAFT REPORT)

GADSDEN HIGH SCHOOL

CAMPUS MASTER PLAN

GADSDEN INDEPENDENT SCHOOL DISTRICT

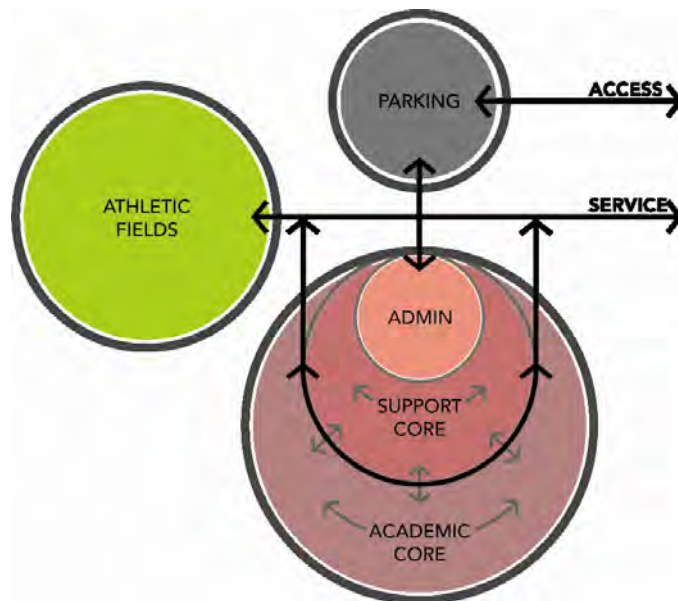
Fig.1: Flow Diagram

The site is organized (**Flow Diagram Fig.1**) to separate vehicular and pedestrian traffic from the buildings and grounds. The buildings are grouped to form passage ways, and are connected by sidewalks and landscaping. From the vehicle parking area, a wide walkway leads directly to the campus administration building. The building is central to the campus along with the core functions of food service, library, counselor, and health. Classrooms and laboratories then circle around the core.

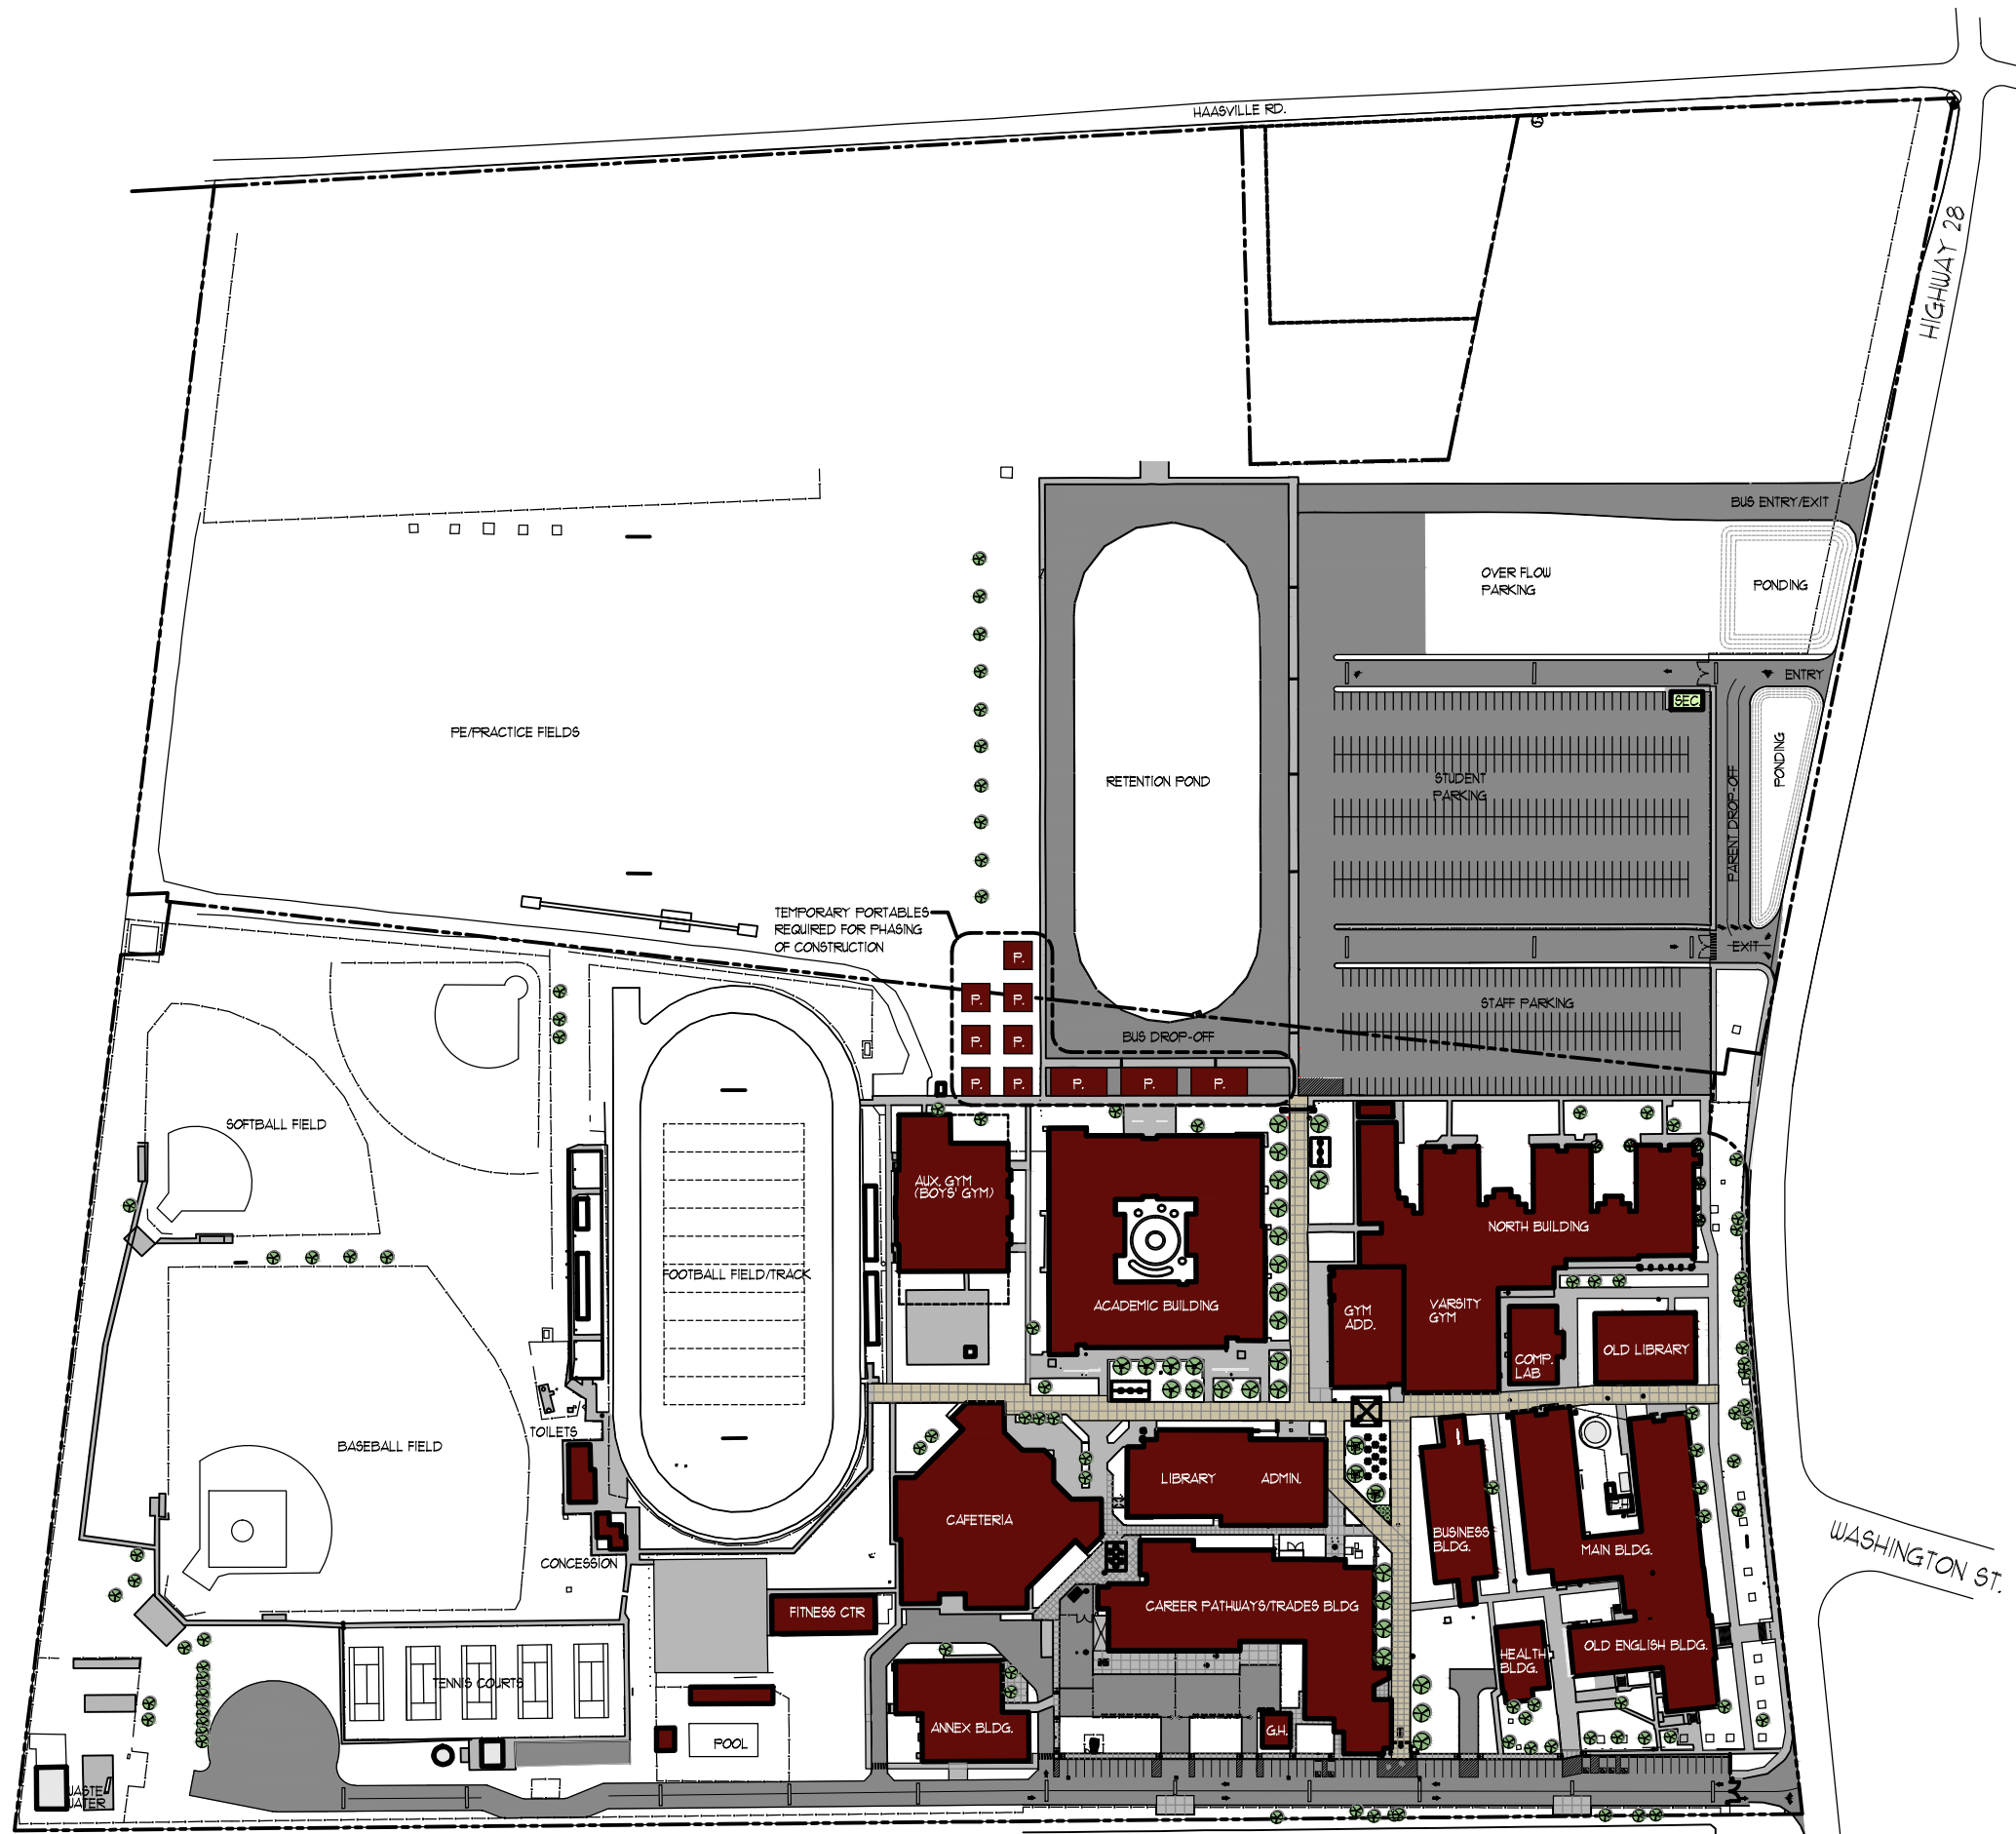
GADSDEN HIGH SCHOOL PURPOSED CAMPUS PLAN

The proposed campus master plan (page 12), illustrates how the departments will be organized on the campus. Section 4- Utilization, gives more detail as to the proposed location of specific programs.

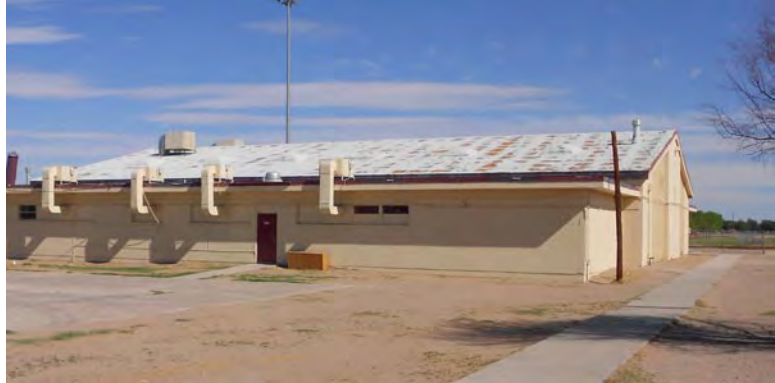
AUXILIARY GYM (BOYS)

Cost	Description
	<p>General</p> <ul style="list-style-type: none"> ▪ The gym is in fair condition and by upgrading it can continue to serve the school. Upgrades includes to lighting, electrical power, roofing, painting, and gym floor. ▪ On two sides of the gym are locker rooms with showers, toilets, and a training room that are in poor condition. To meet District standards it will require major and expensive remodeling and a addition of about 6,0000 GSF. This would still have compromises due to low ceiling heights (8'-0") with no duct space. A possible future District consideration is new construction to replace these rooms. ▪ Comply with all ADA requirements.
	<p>Demolition</p> <ul style="list-style-type: none"> ▪ \$0.42/GSF Abatement ACM thermo insulation ▪ \$0.09/GSF Abatement fire doors ▪ \$2.15/GSF Demolish existing conditions as required for new work
	<p>Shell</p> <ul style="list-style-type: none"> ▪ -0- No structural problems ▪ \$10.25/GSF Roofing

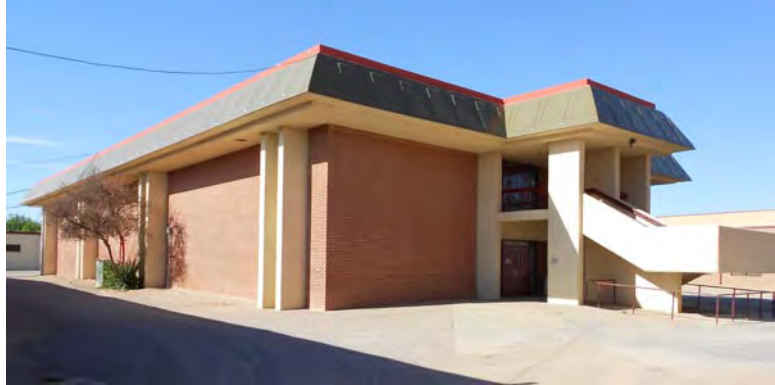
Cost	Description
	General <ul style="list-style-type: none"> ▪ Comply with all ADA requirements including elevator for second floor access ▪ Current departments and support space will be relocated and the building will now be occupied by the science department. The department's location was determined by width of classrooms, stud partitions easily remodeled location adjacent to Career Pathway Building and math department, second floor easily plumbed with access from below, and building size adequate for science department needs ▪ Toilet rooms to remain, but rebuilt with new fixtures, piping, accessories, and finishes ▪ Eight science laboratories upon completion
	Demolition
\$1.90/GSF	▪ Abatement ACM flooring
\$0.08/GSF	▪ Abatement fire doors
\$2.75/GSF	▪ Removal of all walls and ceiling as required for new conditions
	Shell
-0-	▪ No structural problems
\$1.30/GSF	▪ Replace exterior doors and frames

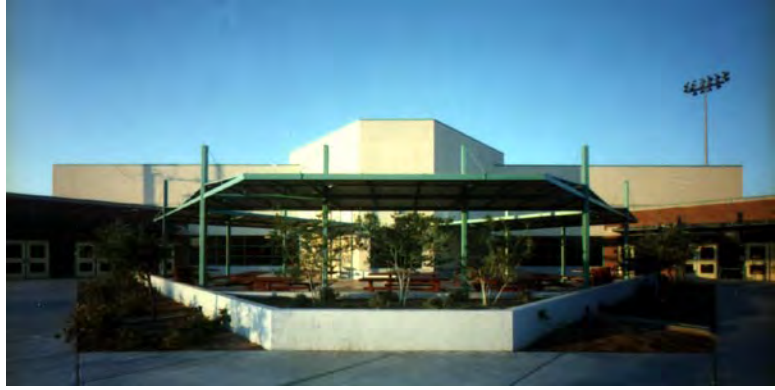
Cost	Description
General	<ul style="list-style-type: none"> ▪ In good condition, requiring minor repairs and refurbishing ▪ Comply with all ADA requirements ▪ Replace evaporative system with refrigerated cooling system ▪ Upgrade electrical to accommodate new cooling system
Demolition	<ul style="list-style-type: none"> ▪ No asbestos ▪ Removal of evaporative coolers and openings in roof for ducts penetrations
-0-	No structural problems
\$9.10/GSF	Roof, 13 years old, will require major repair or new roof with added roof top air conditioning units.
\$1.10/GSF	Repair and paint exteriors
\$2.42/GSF	Replace shade fabric with metal roof panels
\$2.77/GSF	Repair hollow doors and window frames

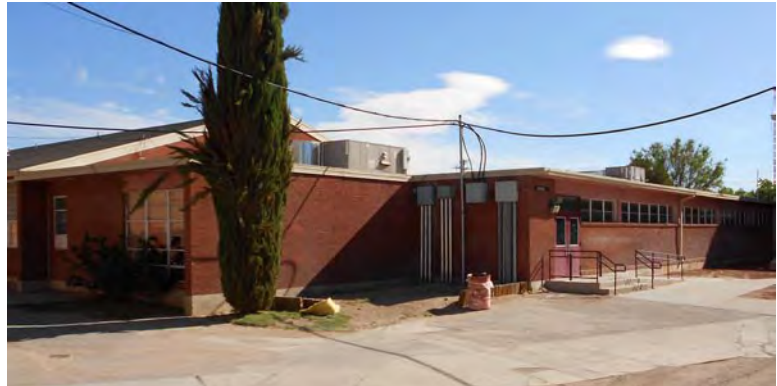
Cost	Description
	<p>General</p> <ul style="list-style-type: none"> ▪ Comply with all ADA requirements. ▪ Ramp between Old English and Main Building for accessibility ▪ Special education, science, administrative, and language arts shall be relocated to other buildings. ▪ Math will be moved into the west and east classroom wings, to be close to the science department and Career Pathway Building. ▪ The wall separating the Old English Building and the Main Building has a 2 hour rating fire door at the corridor. ▪ General classrooms where possible to be a minimum of 800 SF and upgraded to meet district standards ▪ Remodel administration and offices for other uses lobby. ▪ Toilet room to be relocated into vacated administration office area. ▪ Unused old office lobby is to be remodeled into classroom space.
<p>Demolition</p> <p>\$1.50/GSF</p>	<ul style="list-style-type: none"> ▪ Remove walls and ceilings as required for new conditions ▪ Remove toilet rooms, science rooms and other relocated spaces

-0-	▪	No structural problems
\$1.05/GSF	▪	Replace exterior doors and frames
\$17.67/GSF	▪	Replace glass block with stucco walls and windows
\$1.10/GSF	▪	Repair and paint exterior

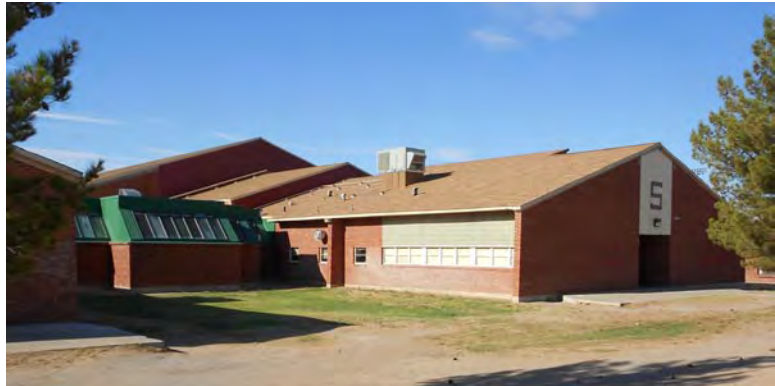
Cost	Description
	<p>General</p> <ul style="list-style-type: none"> ▪ Comply with all ADA requirements ▪ Science laboratories will be relocated to the business building ▪ Toilet rooms to be moved into vacant locker alcoves ▪ ROTC will remain in present location ▪ Adjust general classrooms, where possible, to be a minimum of 800 SF and remodeled to meet district standards ▪ Gymnasium addition - no work required
	<p>Demolition</p>
\$1.28/GSF	▪ Abatement ACM flooring
\$0.06/GSF	▪ Abatement fire doors and lavatory tops
\$0.85/GSF	▪ Abatement thermo insulation
\$0.18/GSF	▪ Abatement drywall joint compound
\$1.50/GSF	▪ Removal of walls and ceilings as required for new conditions
\$0.80/GSF	▪ Remove glass block and adjacent windows
	<p>Shell</p>
-0-	▪ No structural problems
\$2.10/GSF	▪ Replace exterior doors and frames
\$14.67/GSF	▪ Replace glass block with stucco walls and windows

- The Main Building is served by Packaged Rooftop Heating and Cooling (refrigerated) Equipment. The equipment is condition and there will be no notable changes required to this facility from the standpoint of HVAC upgrades. Ductwork will be reconfigured based on floor plan changes.

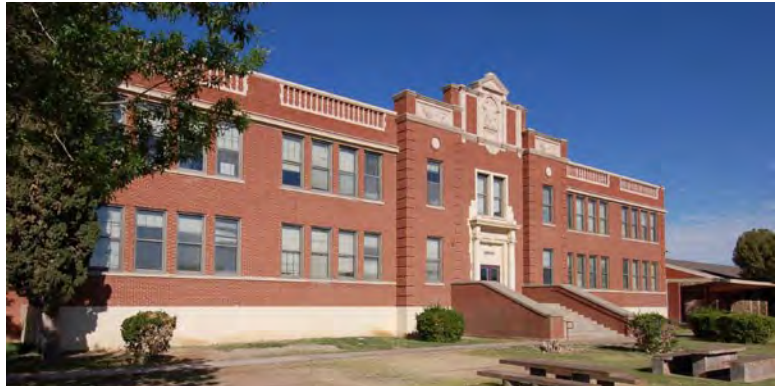
- Comply with all ADA requirements
- The two story building is in reasonable condition, well constructed and maintained. Corridors floors are of reinforced concrete with masonry walls. Classroom floors and roof are framed lumber with no fire protection.

- Exterior windows installed in 1980's are broken, leaking, non operable, and are not historically appropriate. The Mechanical Engineers have requested the windows be replaced to decrease heat loads.

\$4.25/GSF	▪	Replace exterior windows and doors to match original in 1928 building
\$3.70/GSF	▪	Repair stone sills and caps, and masonry
\$7.97/GSF	▪	Reroof all parts
\$2.70/GSF	▪	Reinforce wood floors at classrooms as required

- The Old English Building had an upgrade project completed within the last 10 years where the Boiler and pumps were replaced and new Fan Coil units (floor cabinet types) were installed as replacement to the original convectors. A fresh air system was added; air is supplied from the roof. The Girls Gym (part of Old English) had a heating Air Handler replaced. Cooling is provided via Evaporative Coolers. The Coolers are still in good condition however some of the space will be considered for a conversion to Refrigerated cooling to be consistent with other learning spaces in the district and on this campus. A 4000 sf addition will be included in the work.

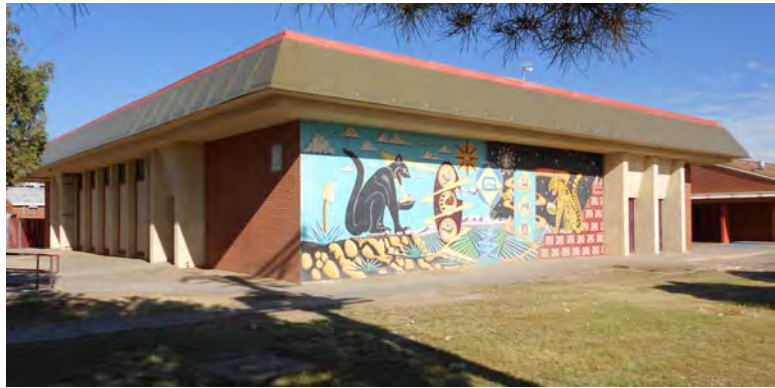
Cost	Description
General	
	<ul style="list-style-type: none"> Originally designed as a kitchen/cafeteria with a stage. Enrollment outgrew the cafeteria's capacity and the building has had several different uses before becoming the library. Now it will be remodeled for a black box performing theater with seating for approximately 100, a slightly raised stage, control booth, storage, green room, and changing room Comply with all ADA requirements
Demolition	
\$1.50/GSF	<ul style="list-style-type: none"> Remove partitions and ceiling as required
\$2.10/GSF	<ul style="list-style-type: none"> Remove finishes in toilet rooms
\$1.65/GSF	<ul style="list-style-type: none"> Abatement ACM flooring
\$.019/GSF	<ul style="list-style-type: none"> Abatement fire doors
\$1.10/GSF	<ul style="list-style-type: none"> Remove windows and doors as required
Shell	
-0-	<ul style="list-style-type: none"> No structural problems

\$18.78/GSF	▪	Structures under raised seating
\$25.40/GSF	▪	Remodel interior partitions and ceilings as required for new conditions
Included	▪	Remodeled toilets with new toilet partitions and accessories
Included	▪	Review hardware for adequacy

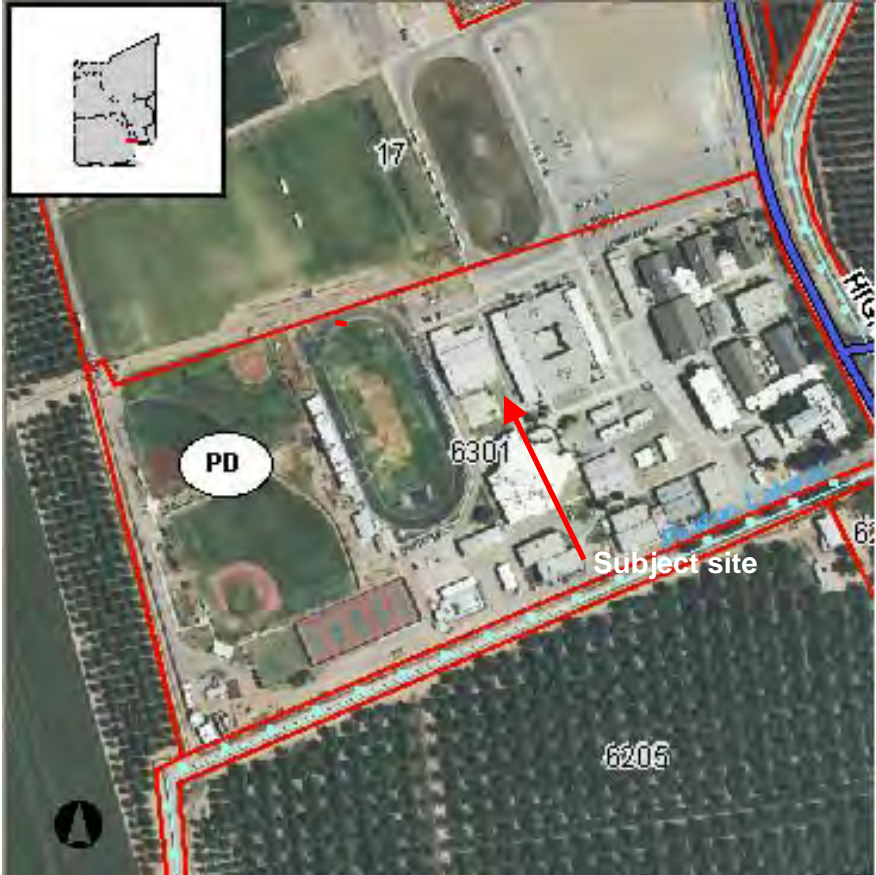
Figure 2-3 Zoning Designation

The tract of land for the existing development is currently zoned for a performance district (PD) as shown in Figure 2-3 below.
